**Operation and Maintenance Report
January 2016 to December 2016**

McCormick and Baxter Superfund Site

Portland, Oregon

March 23, 2017

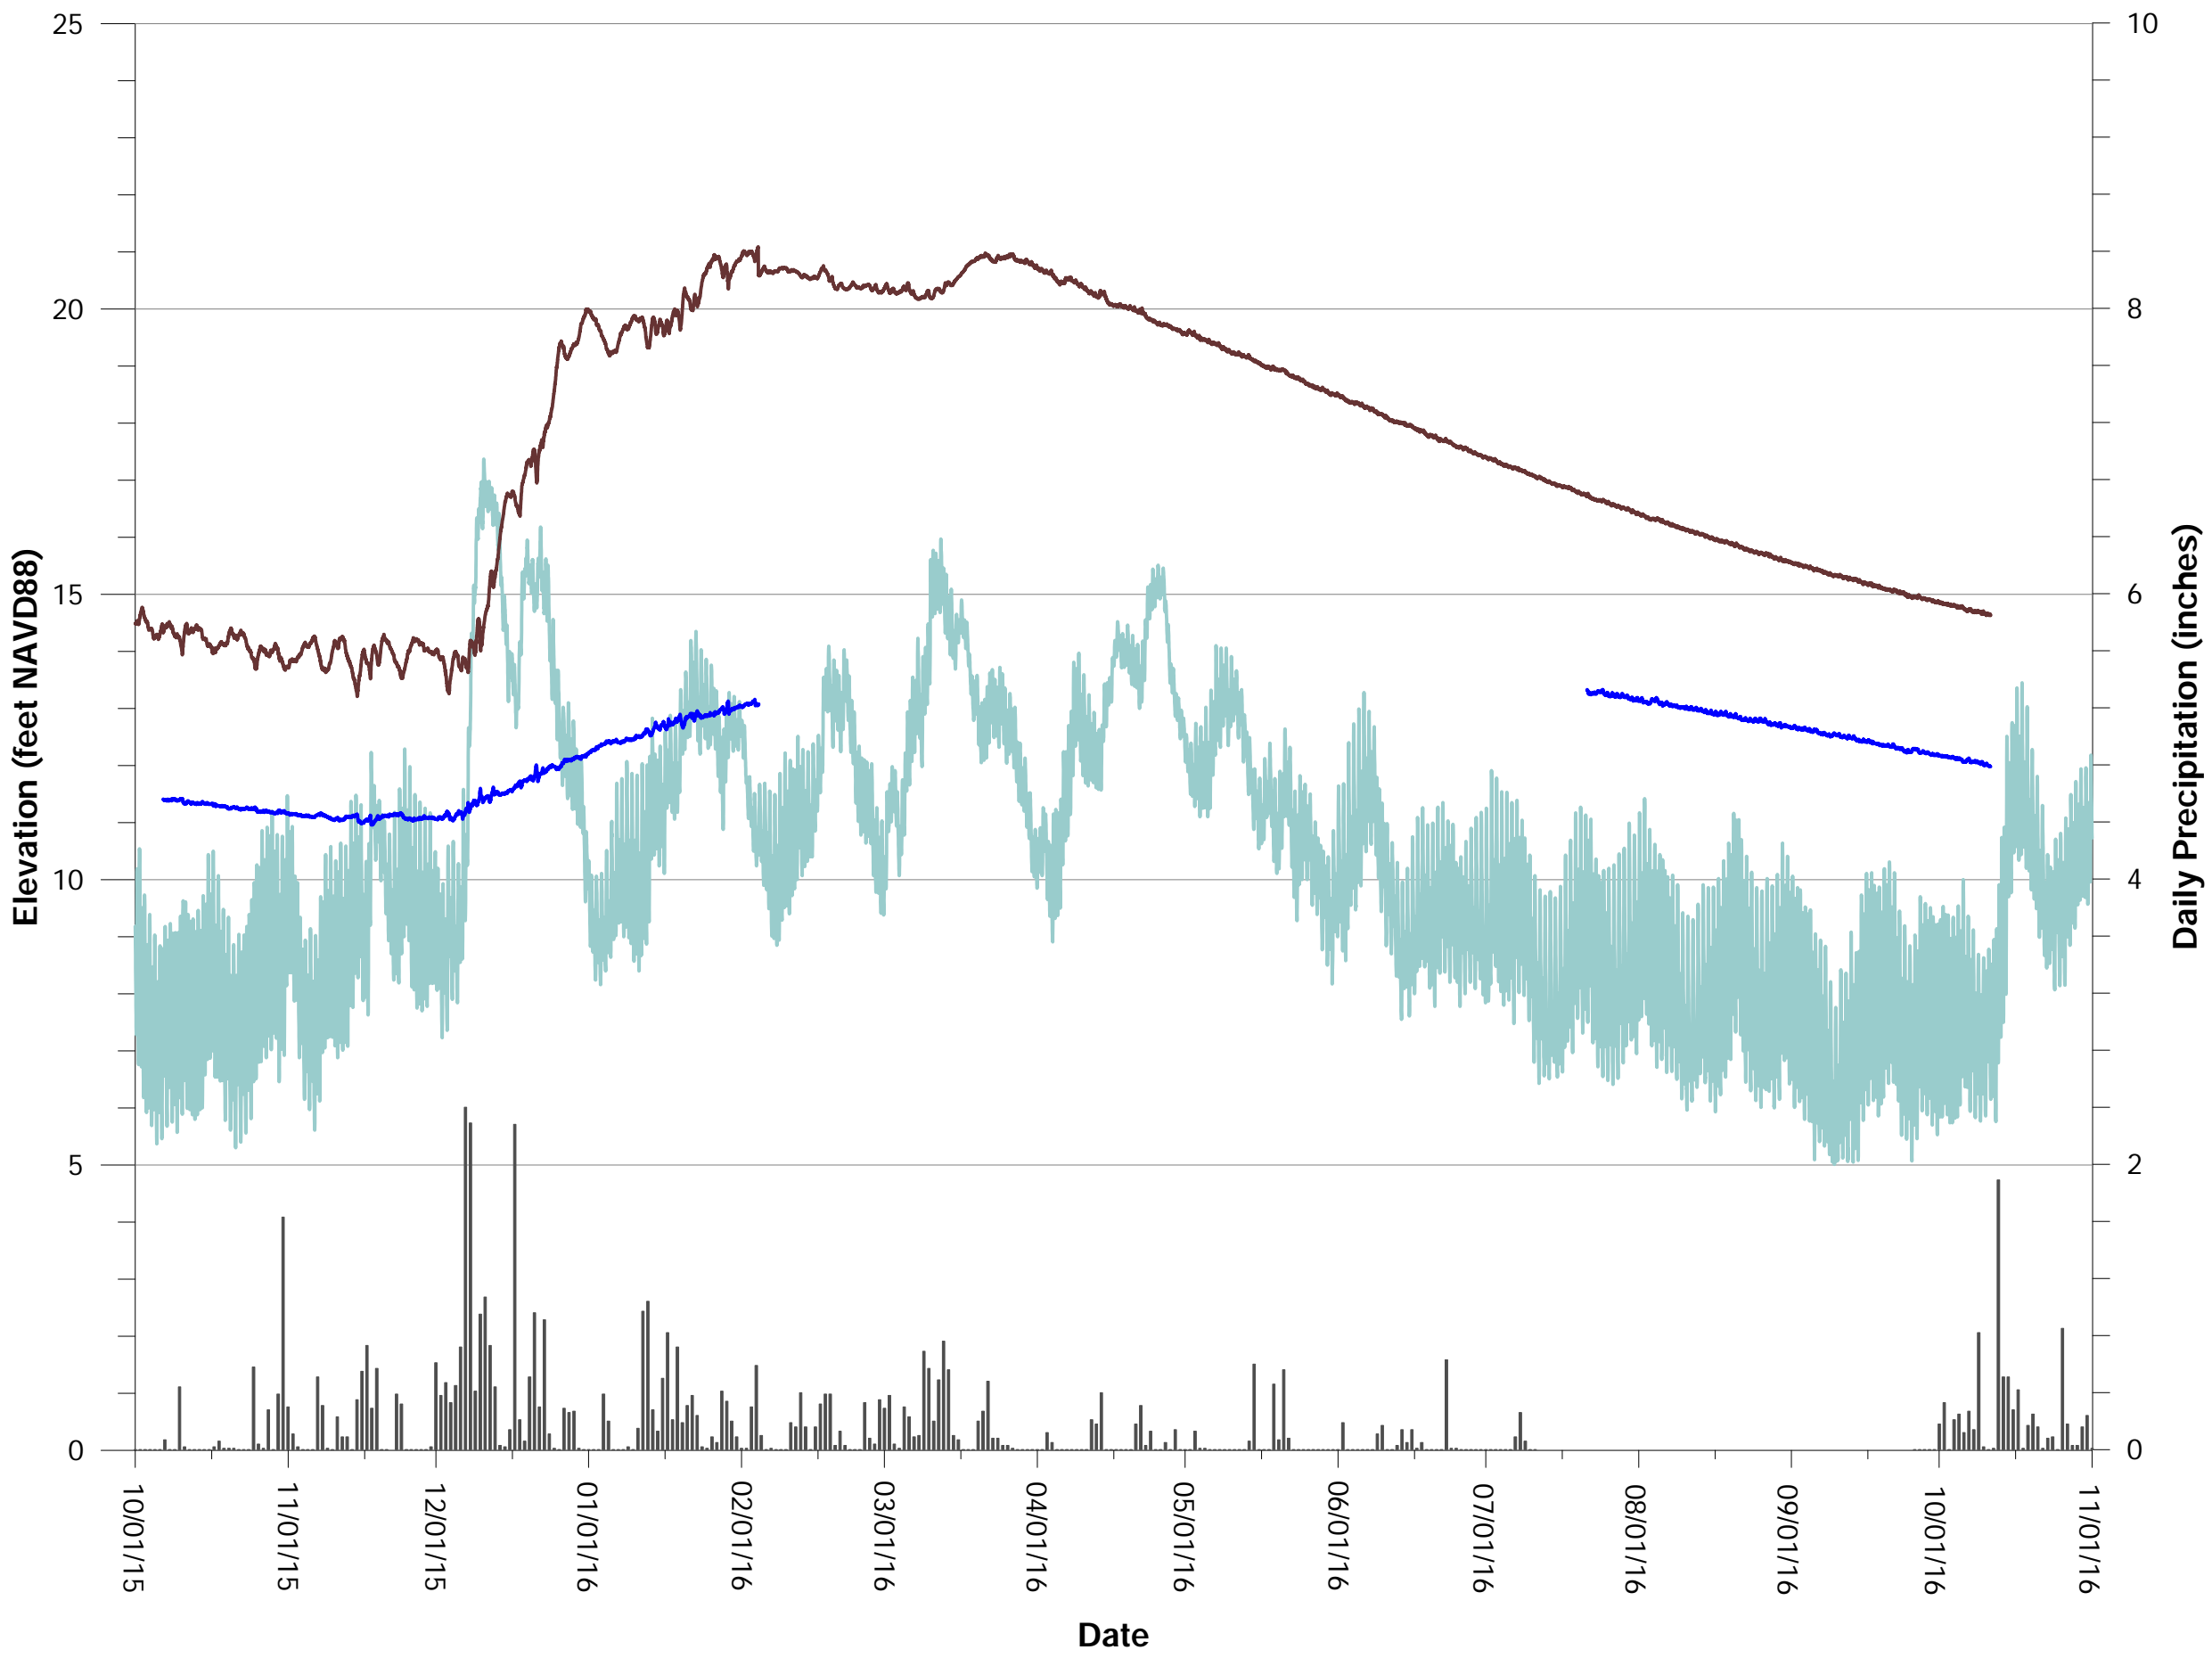
Figure 4-5:
2016 Groundwater Elevations
Monitoring Wells MW-52s and MW-53s
McCormick and Baxter Superfund Site
Portland, OR

The break in MW-52s data (Figure 4-5) occurred as a result of a programming error. The transducer was installed but did not start recording data and the problem was not realized until data was downloaded in the summer. Currently, all transducers at the site are functional and installed in the wells shown on Figure 4-1.

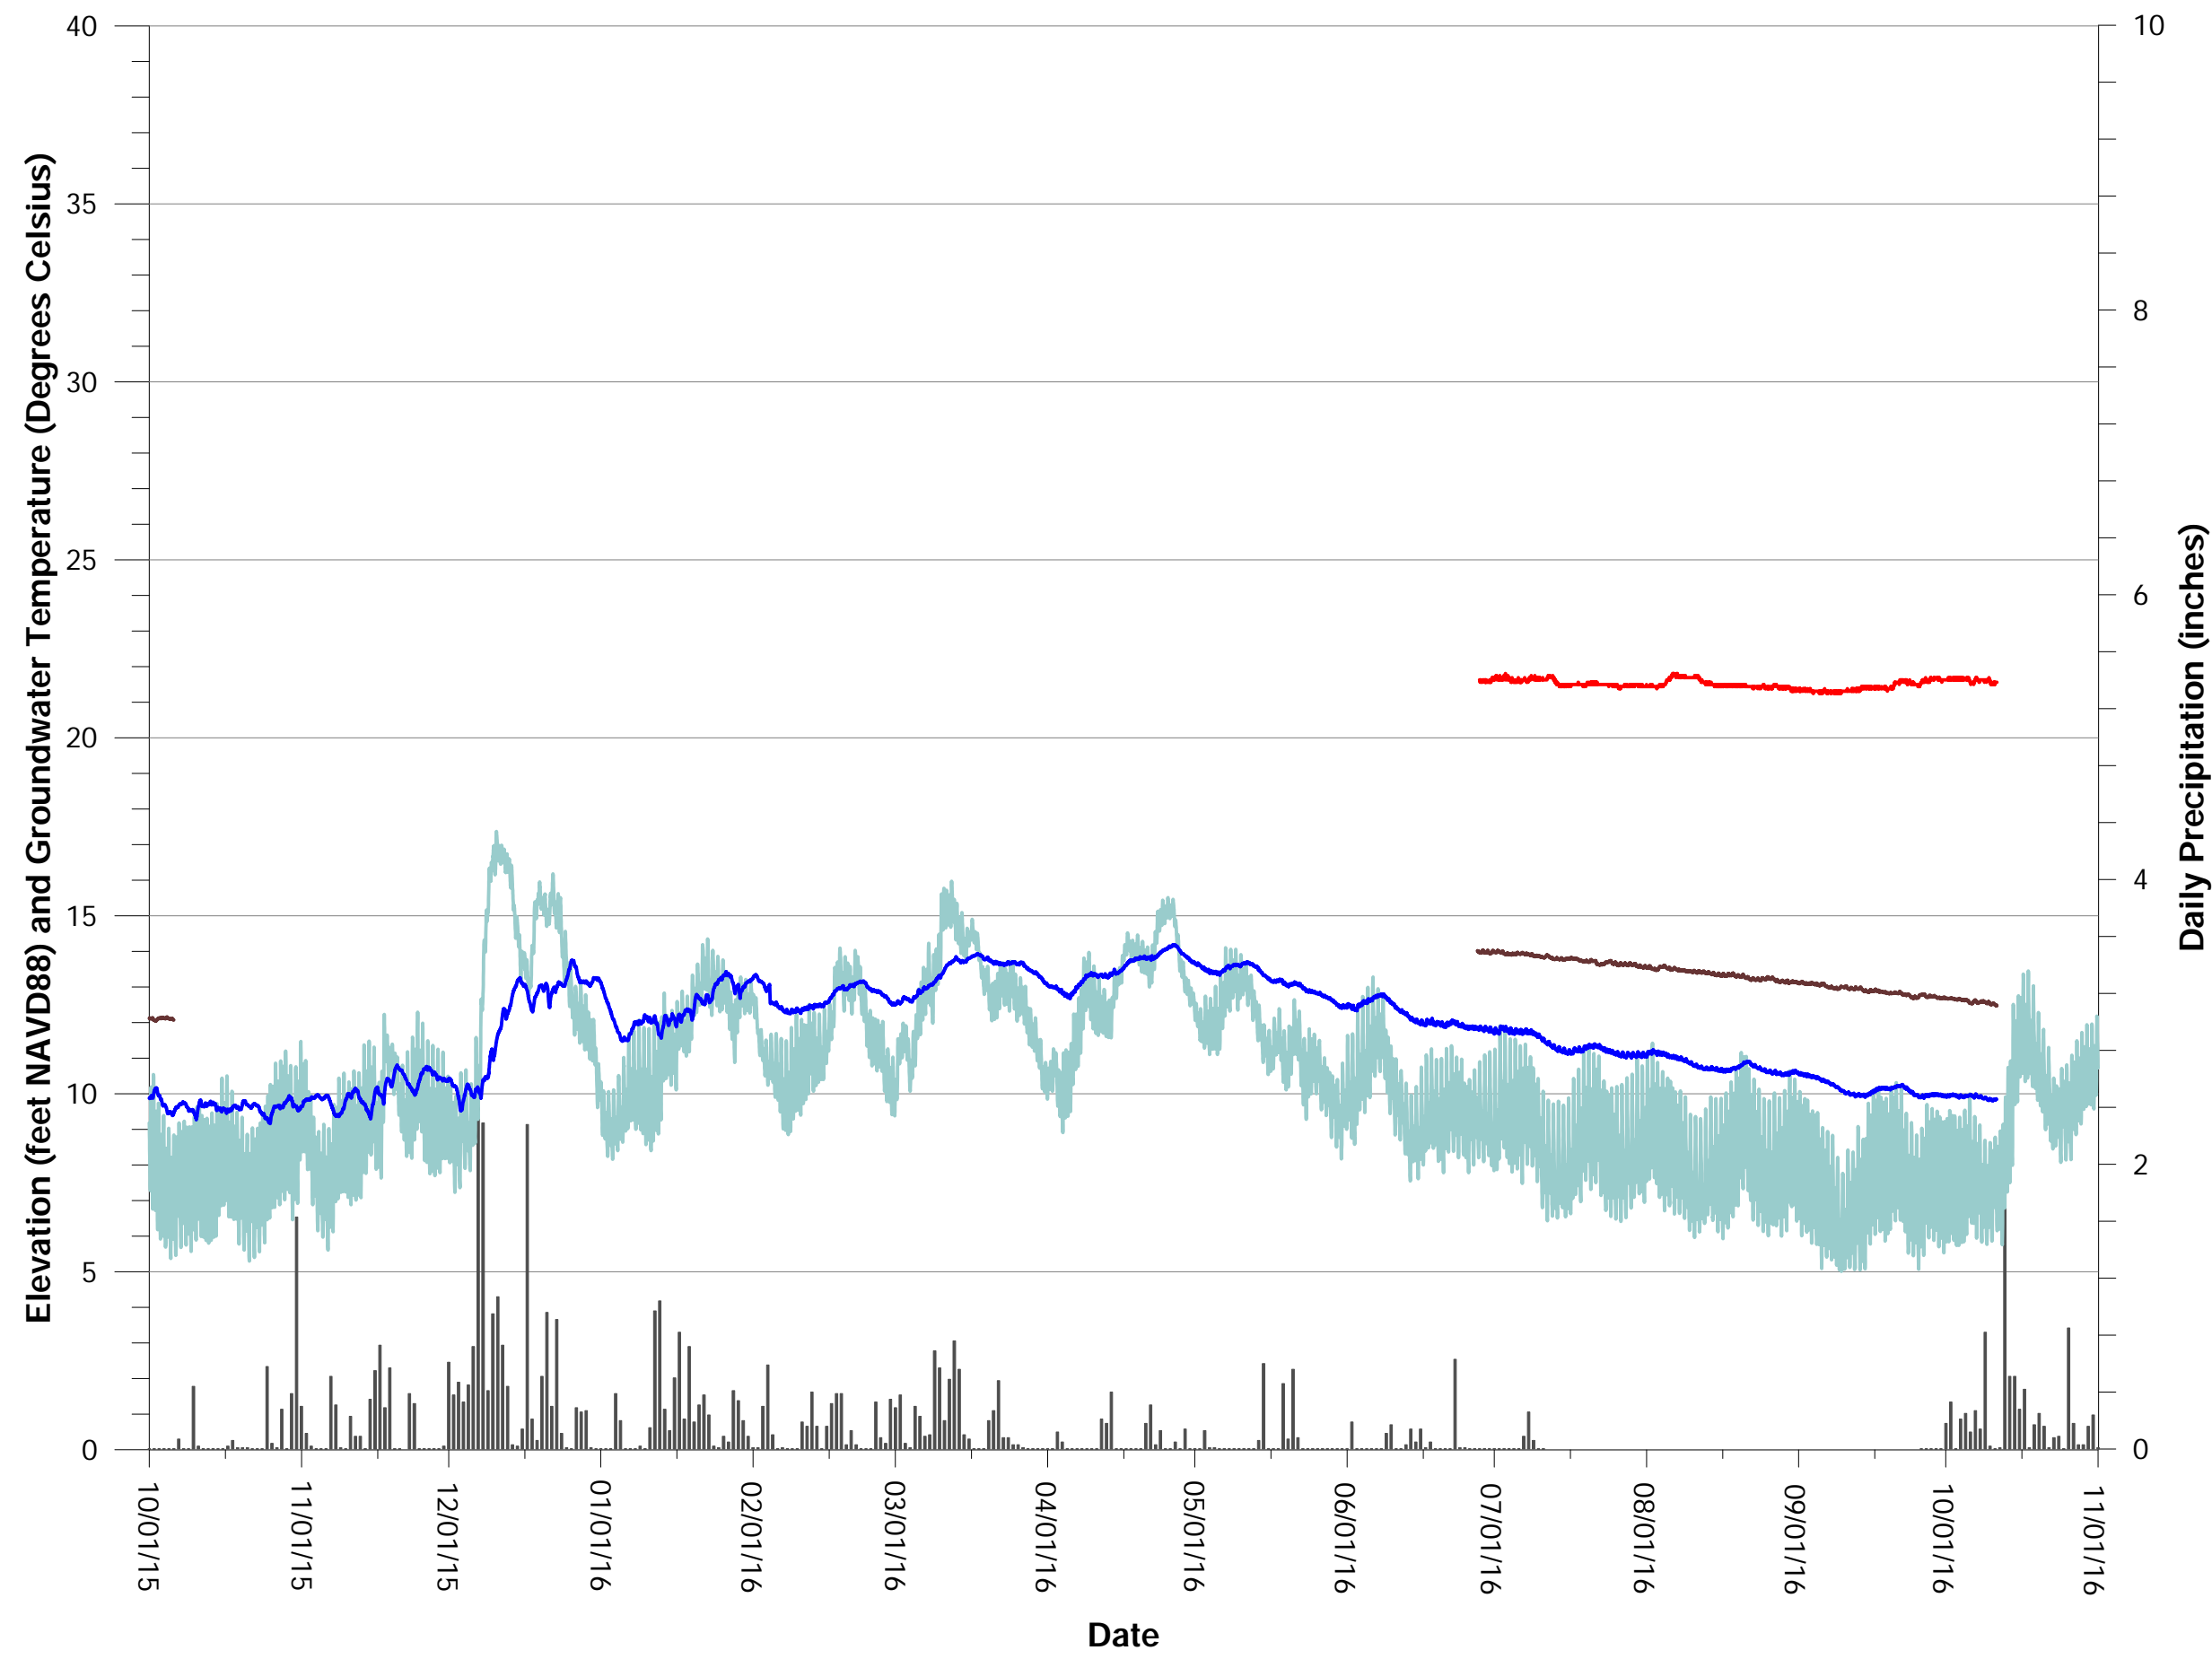
Figure 4-7:
2016 Groundwater Temperature
in Monitoring Well EW-1s and
Groundwater Elevations
Monitoring Wells MW-36s and EW-1s
McCormick and Baxter Superfund Site
Portland, OR

Based on elevated groundwater temperatures in well EW-1s (40 °C) and the large amount of buried woody debris in the area, it is suspected that aerobic degradation of woody debris was occurring and causing the ground surface subsidence. Decreasing groundwater levels within the barrier wall also may have contributed by opening a larger unsaturated zone that allows compaction. In 2009, the shallow well EW-1s, was sealed to reduce the amount of oxygen reaching the unsaturated zone. Since the well was sealed, the subsidence has slowed and no additional subsidence has been observed the past four years. The groundwater temperature dropped to approximately 21-23°C and has remained stable for the past 6 years. This temperature is still higher than groundwater from surrounding wells (approximately 13°C) indicating that some heat is still being produced in the subsurface near well EW-1s; this may be caused by anaerobic degradation, which generates less heat than aerobic degradation.

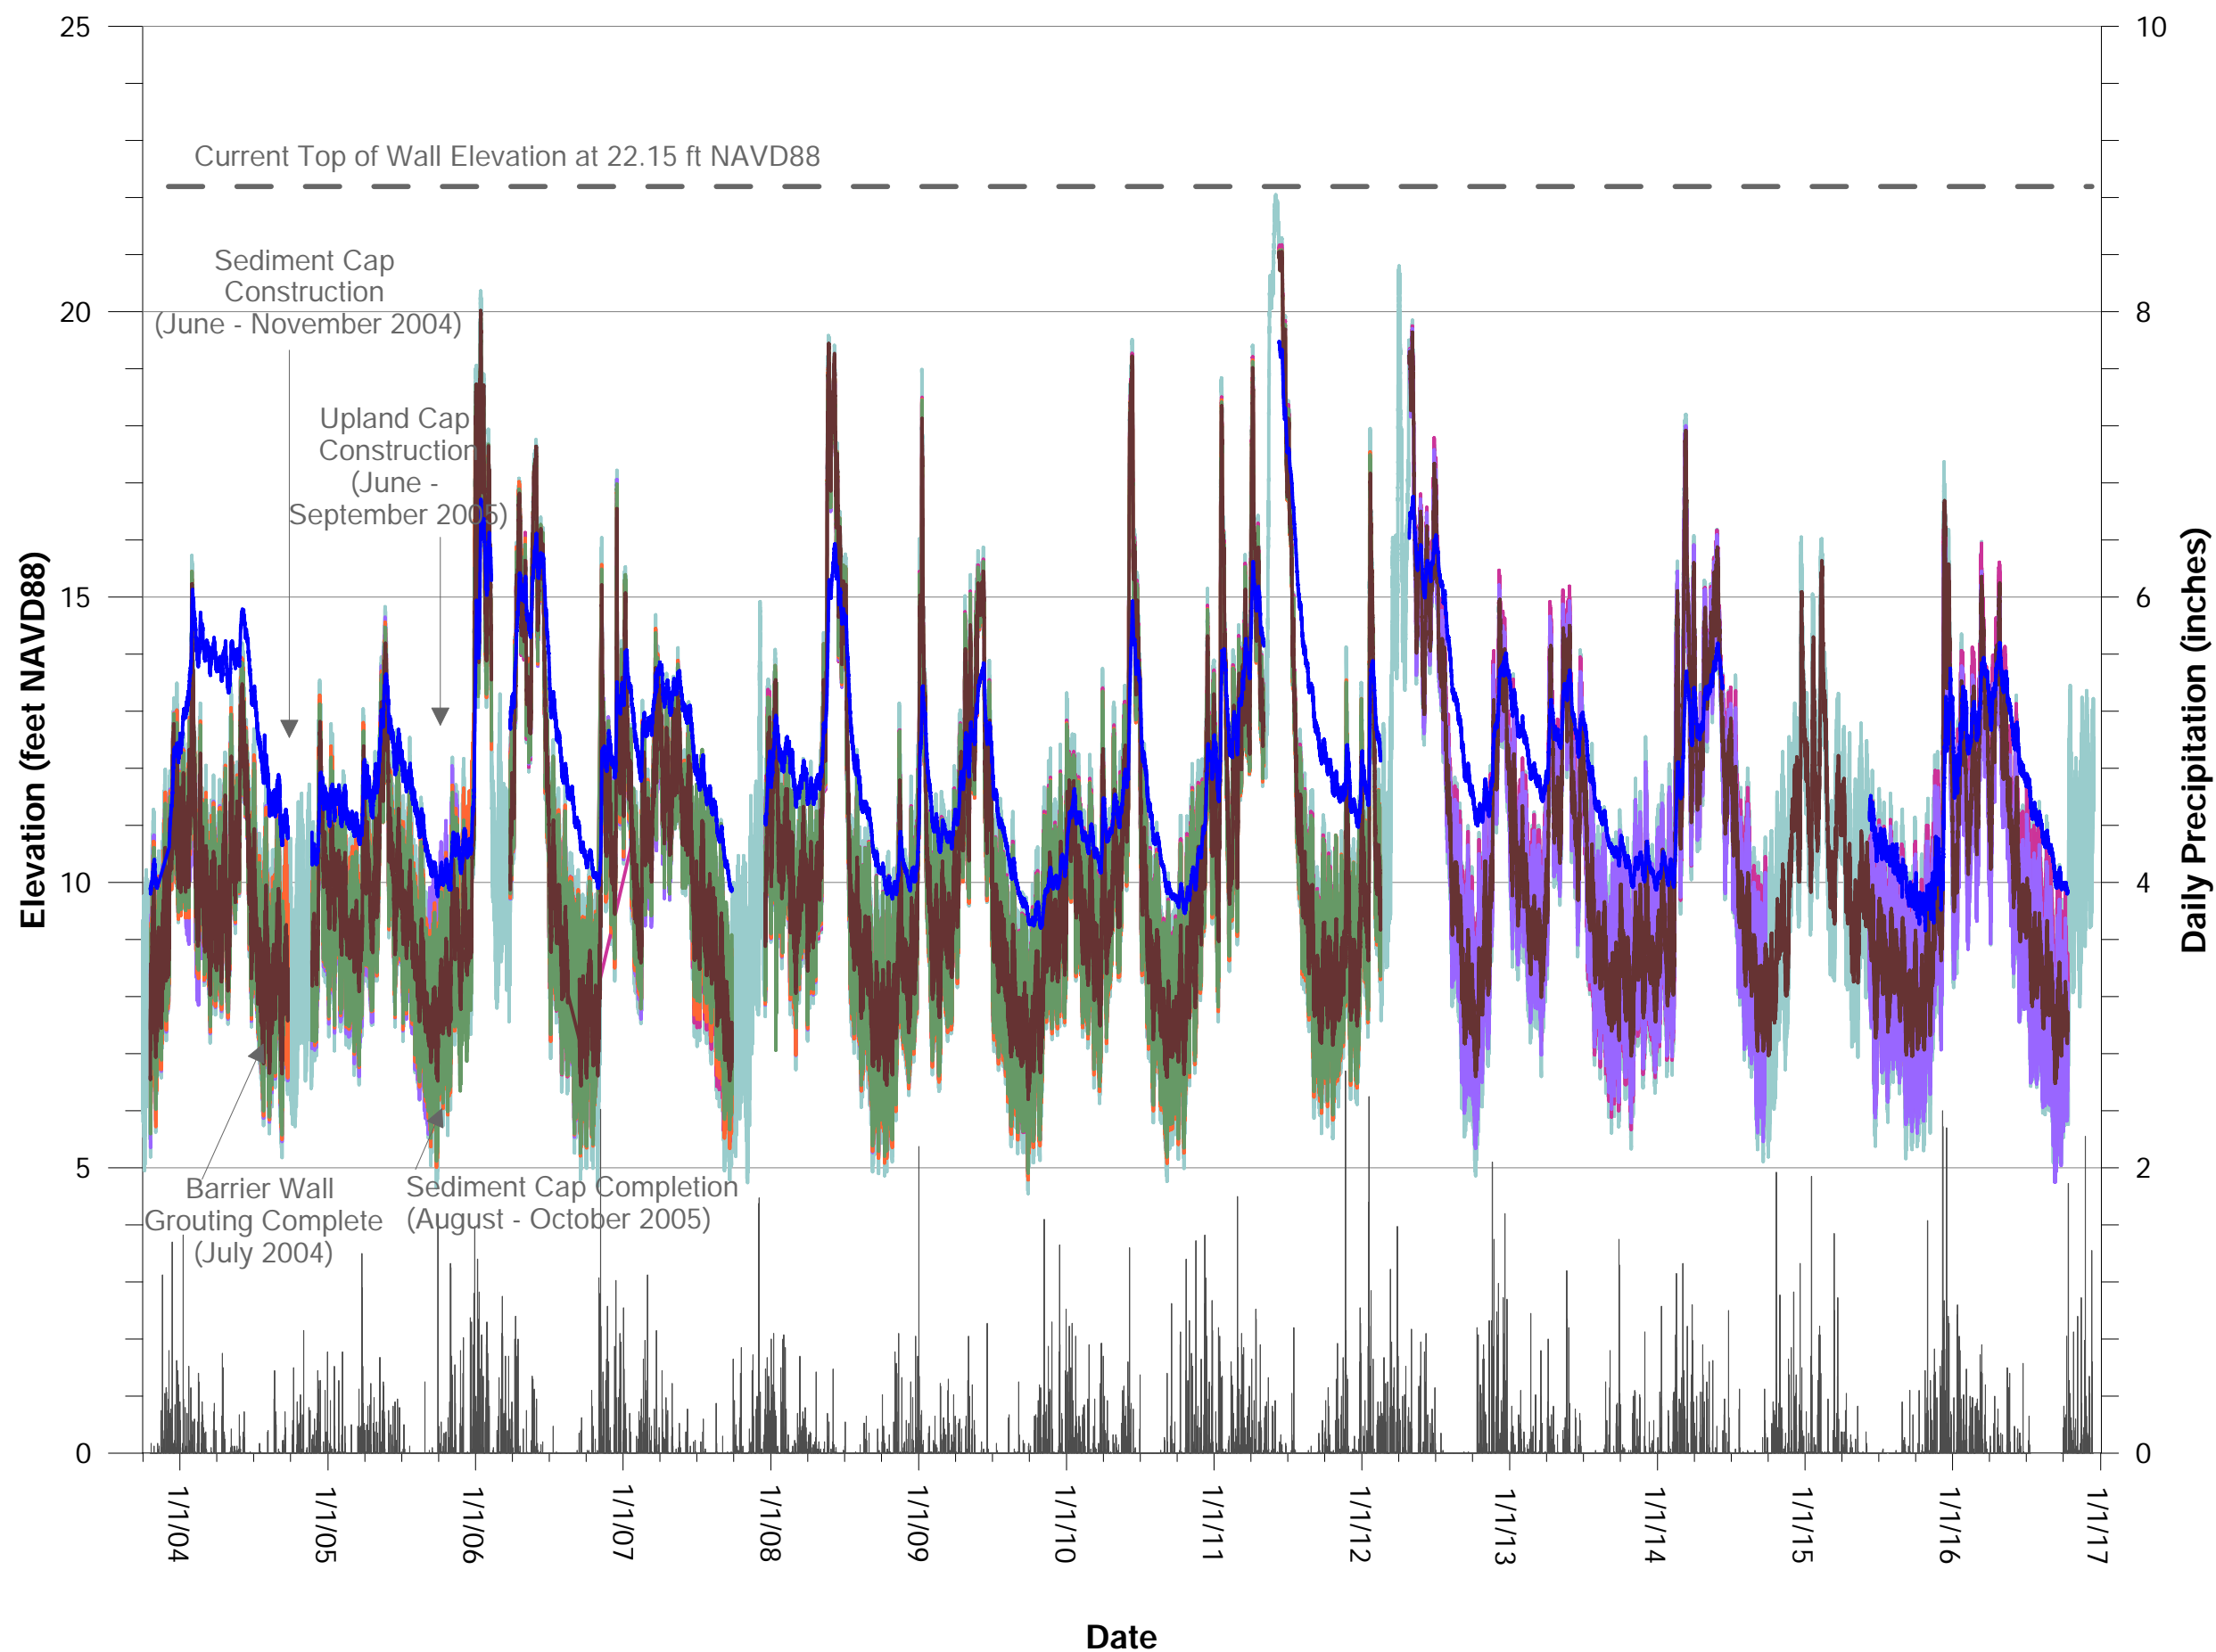
Figure 4-8:
Post-Barrier Wall Groundwater Elevations
in Monitoring Wells MW-36 and MW-37

Vertical gradients inside and outside the barrier wall along the Willamette River were observed in monitoring well clusters MW-36/MW-37 and MW-44/MW-45. The hydrographs for these wells (Figures 4-8 through 4-11) indicate that the deep groundwater zone is in direct hydraulic connection with the river. The deep zone both inside and outside of the barrier wall closely mimics the river stage, both in elevation and timing, with a small vertical gradient that varies upward and downward with the tidal changes. The exterior shallow wells, also in hydraulic connection with the river, show about a quarter cycle delay from river fluctuations and have dampened amplitude in comparison with the deeper wells.

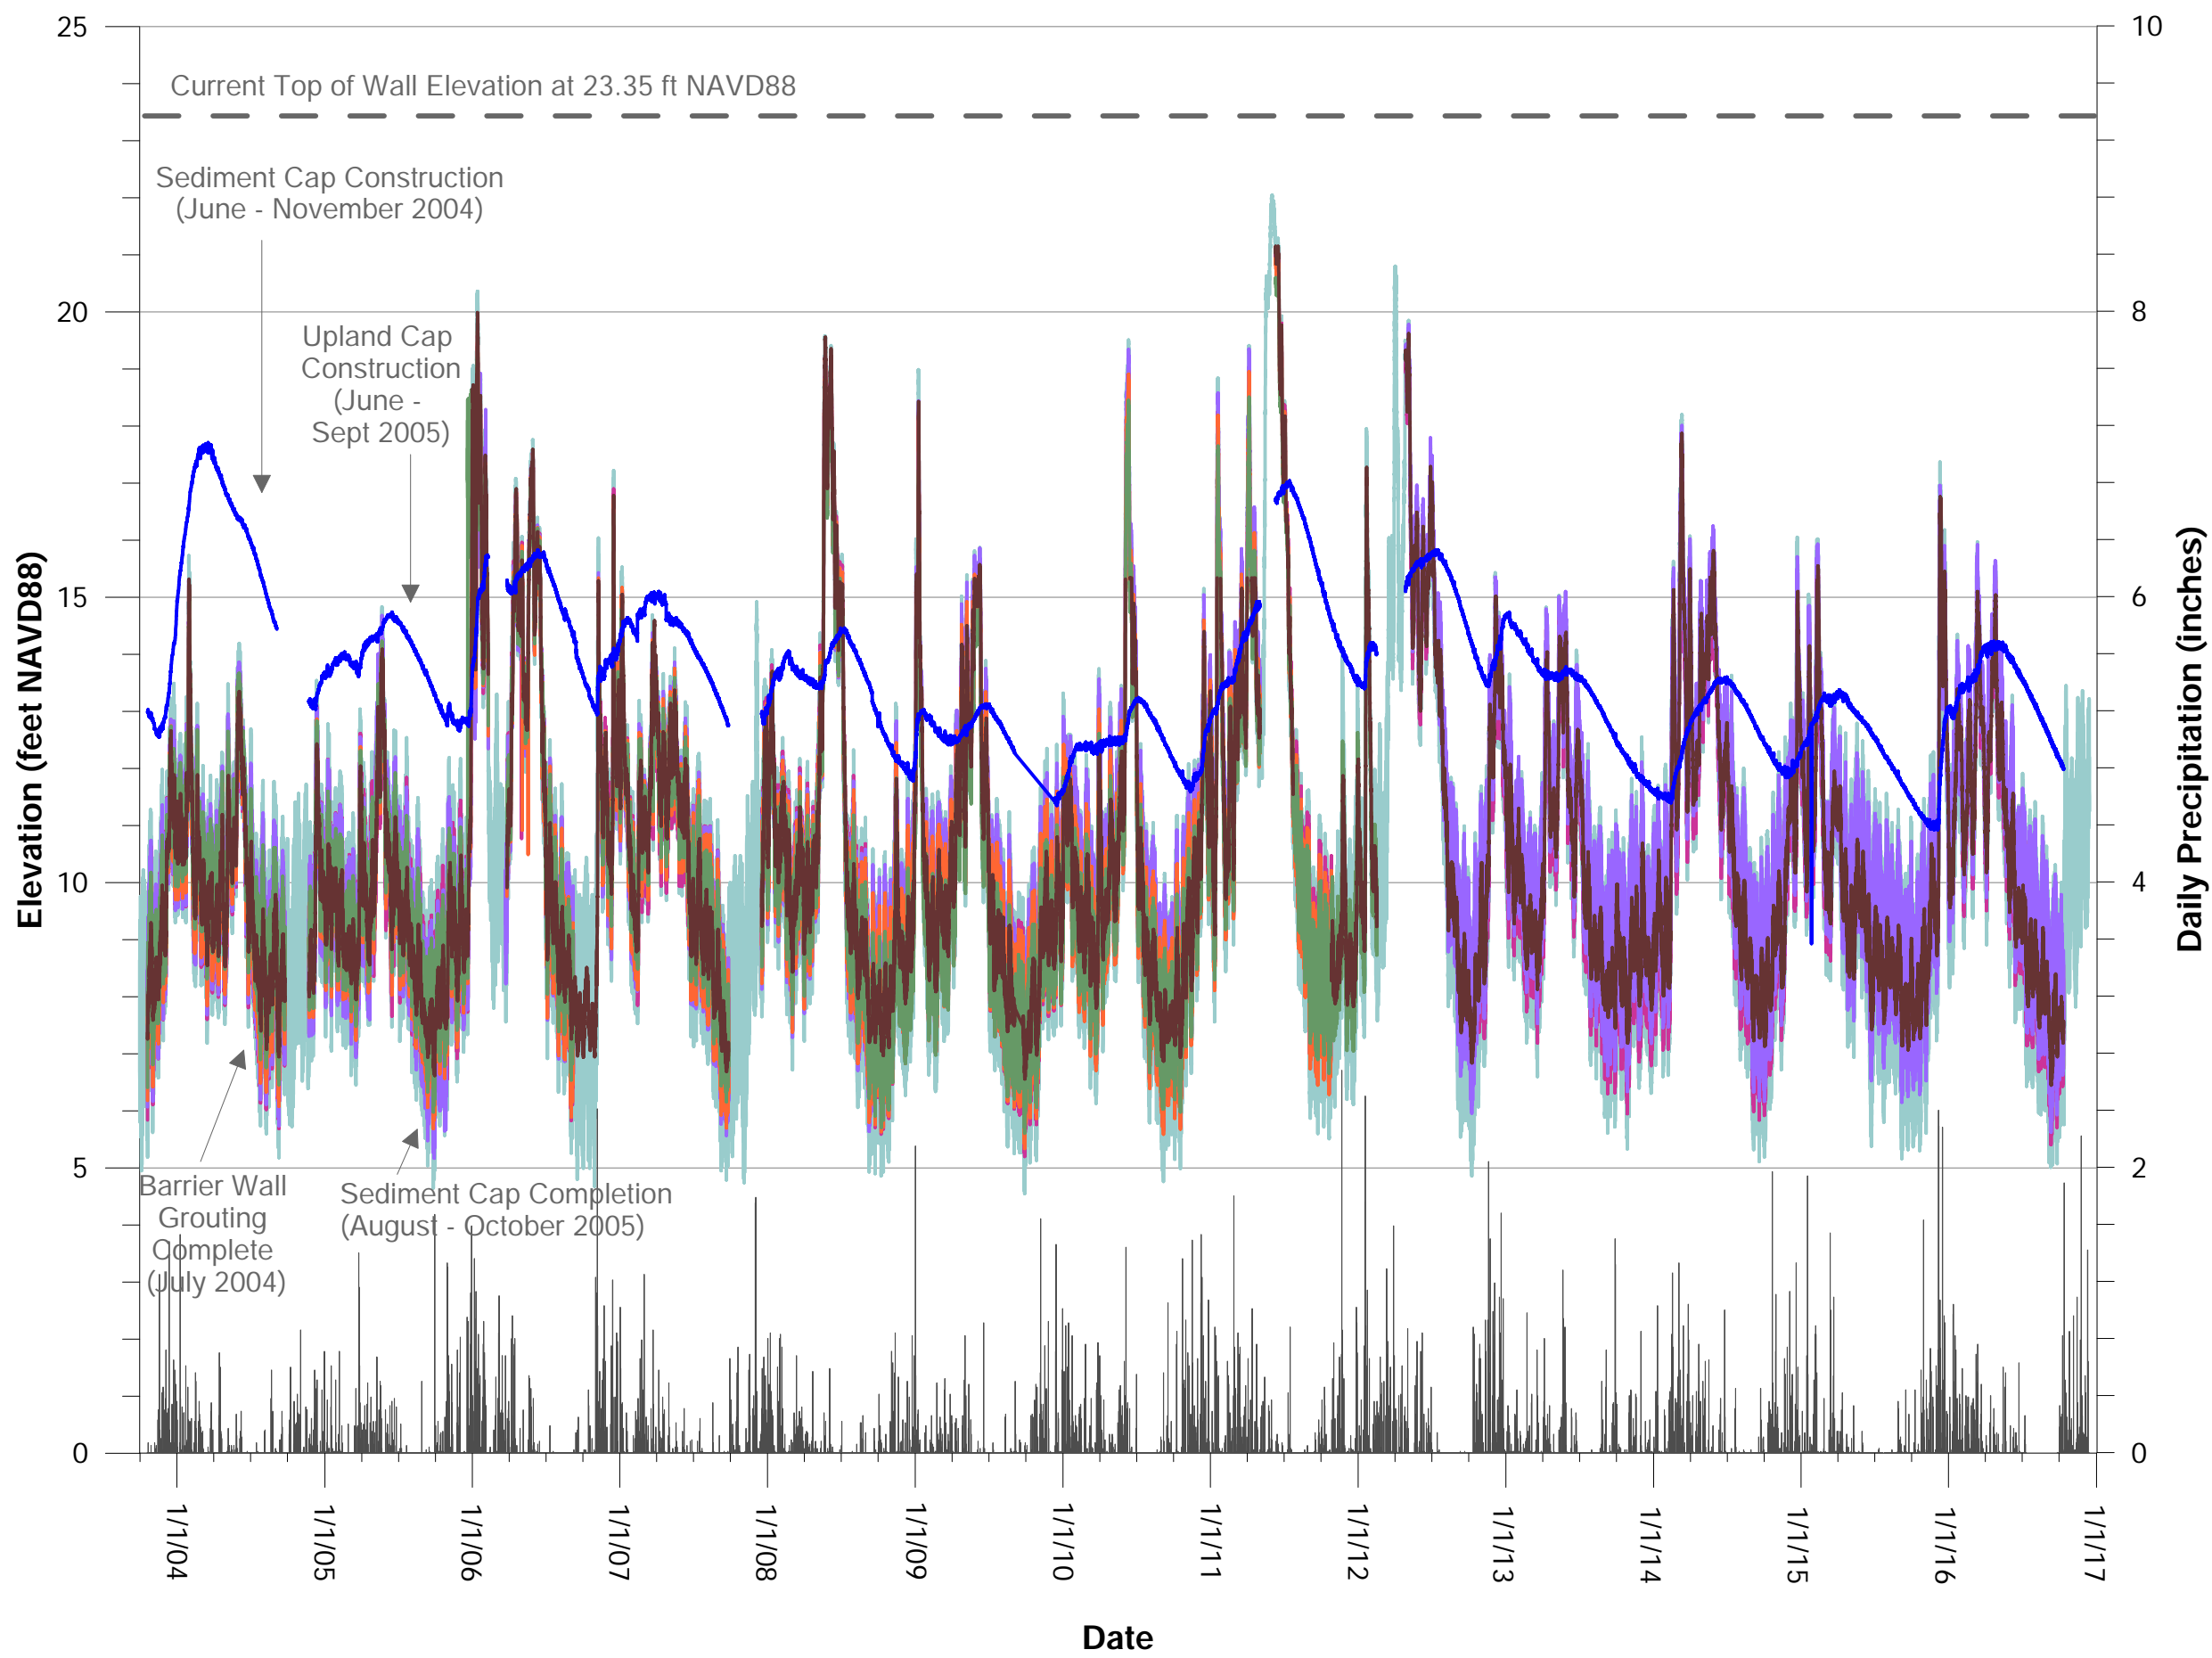
Figure 4-10:
Post-Barrier Wall Groundwater Elevations
in Monitoring Wells MW-44 and MW-45

The muted or nonexistent response of interior shallow wells compared with the deep zone wells suggests a clear hydraulic disconnect between the shallow aquifer within the barrier wall and the deeper water-bearing zones. The location where the response is greatest, but still significantly muted, is in well MW-36s (Figures 4-6 through 4-9), where a hydraulic connection exists at the base of the barrier wall. While a muted response of well MW-36s to changes in daily river stage elevation is still observed, water levels in the shallow interior wells MW-44s and EW-1s are virtually non-responsive to the daily changes in the Willamette River stage (Figures 4-10 and 4-11 for MW-44s, and Figures 4-6 and 4-7 for EW-1s). This reflects the presence of a confining silt layer between the shallow and intermediate zones near wells MW-44 and EW-1s.

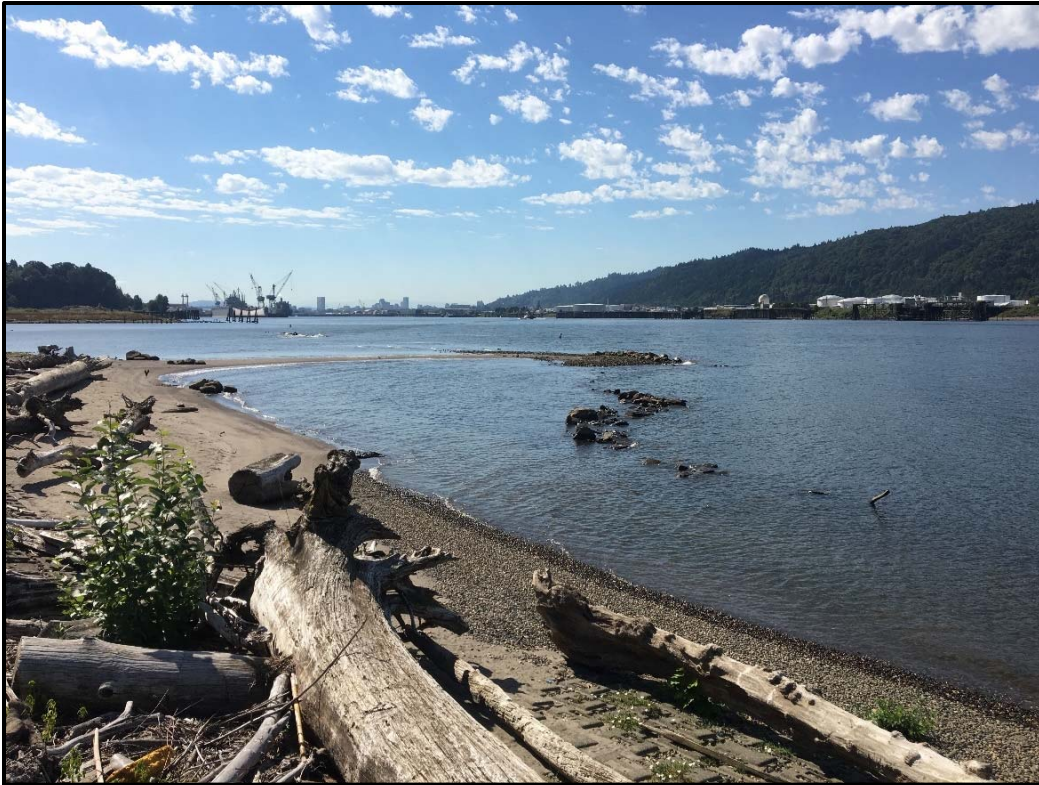
Photograph 13 – Sediment cap looking south in July 2016.

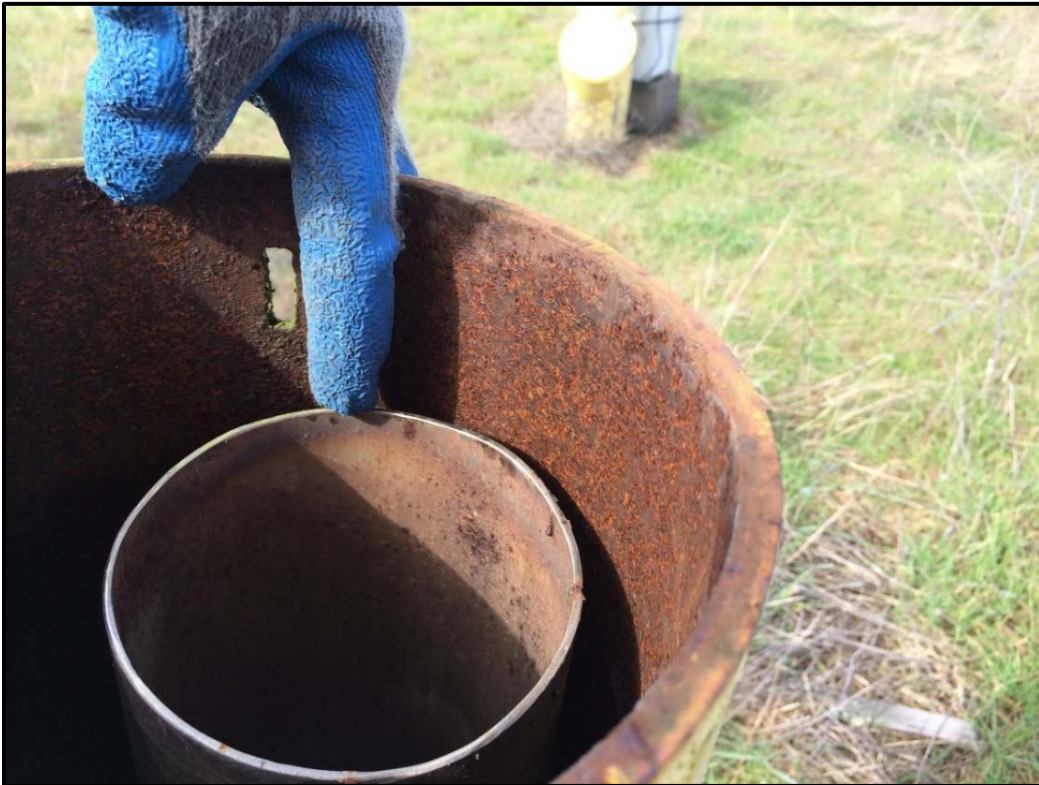
Photograph 14 – Inner casing measuring point on well MW-23d.

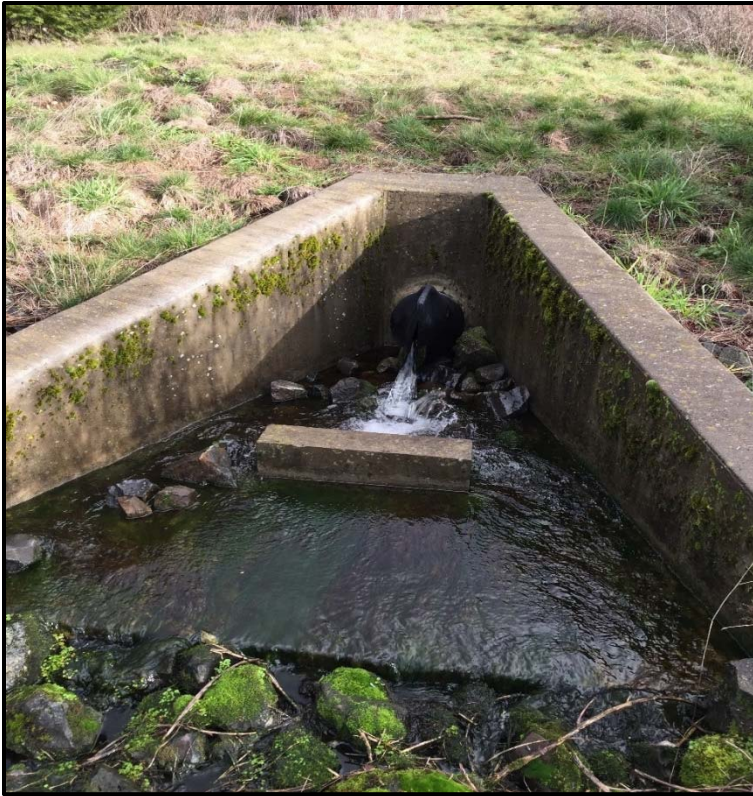
Photograph 15 – Stormwater drainage at outfall during January 2016 site inspection.

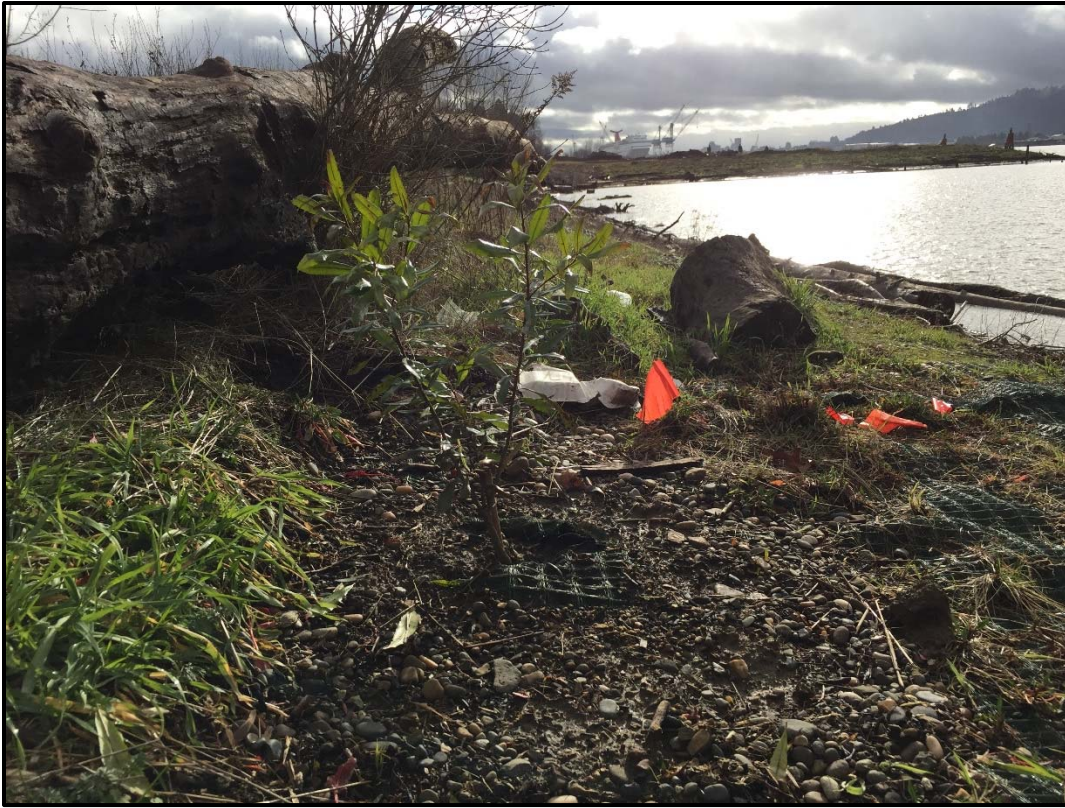
Photograph 17 – Pacific wax myrtle (Myrica gale) planted during TRM repairs in December 2015 as observed in during January 2016 site inspection.

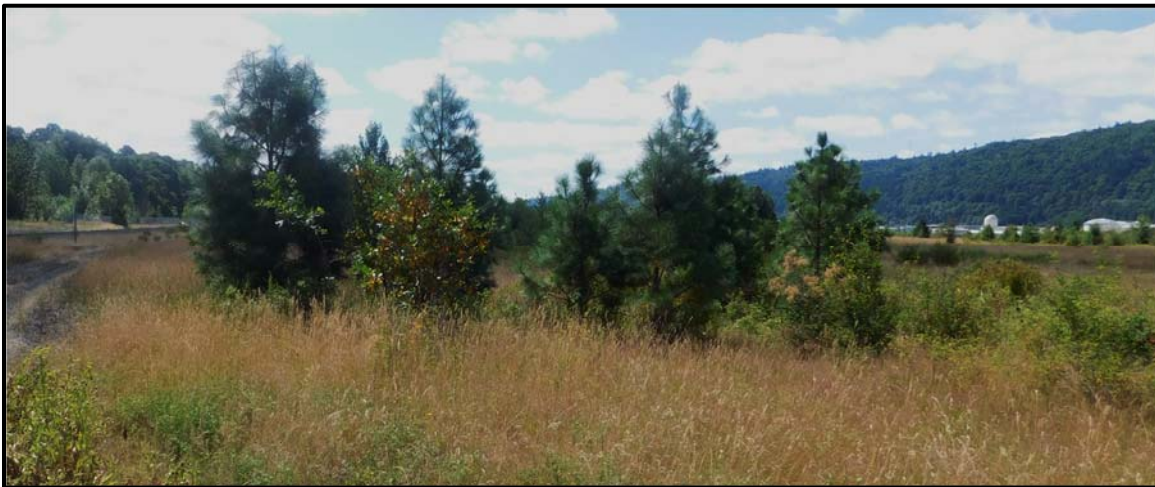
Earthen Cap Component. Tree and shrub plantings on the earthen cap were healthy and growing well (Photographs 2, 3, and 5, Appendix C). Ponderosa pine, Oregon grape, elderberry, and serviceberry were performing the best. Nootka rose dominated the northwest portion of the earthen cap and were previously stressed, but have recovered well. Trees and shrubs ranged in height from approximately 6

Photograph 2 - Tree and shrub plantings on the earthen cap. Taken looking southeast from Photograph Location 2. (June 2016)

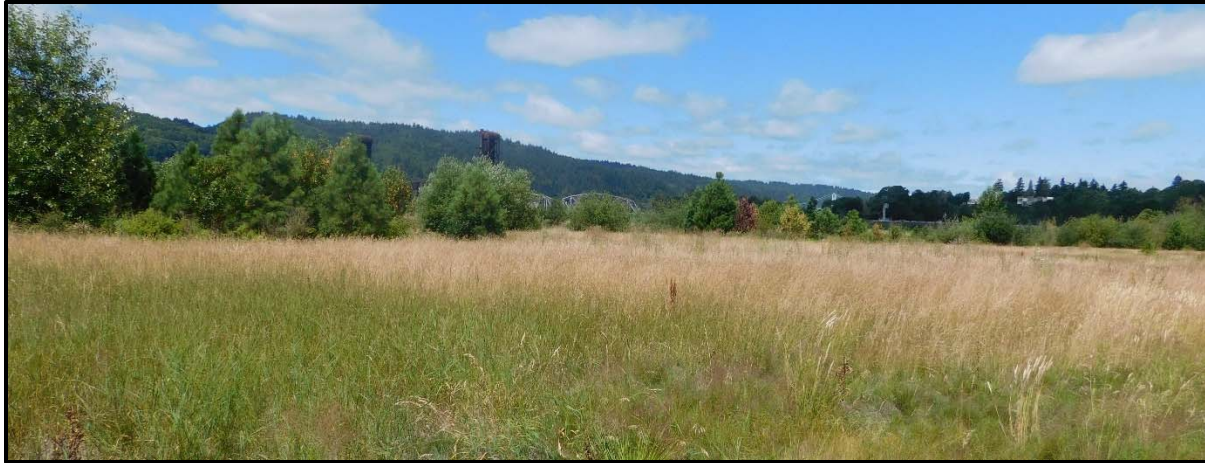
Photograph 3 – Eastern edge of the earthen cap looking toward the drainage swale. Taken looking west from Photograph Location 3. (June 2015)

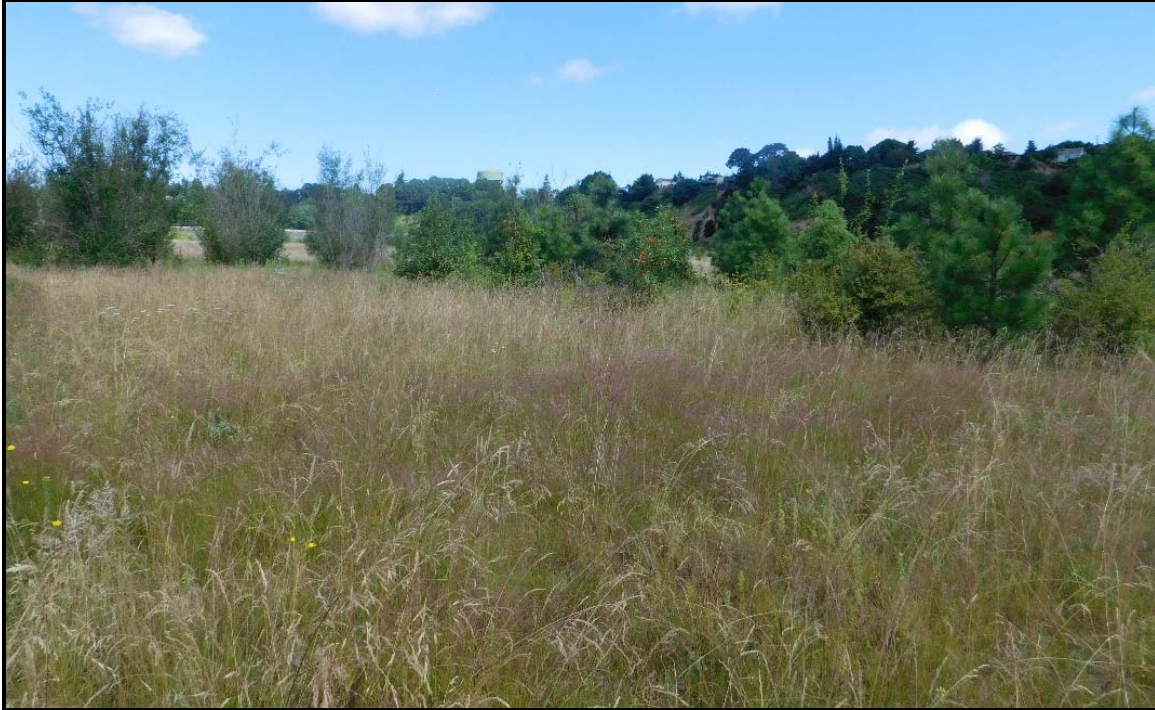
Photograph 5 – Tree plantings on the earthen cap. Taken looking north from Photograph Location 5. (June 2015).

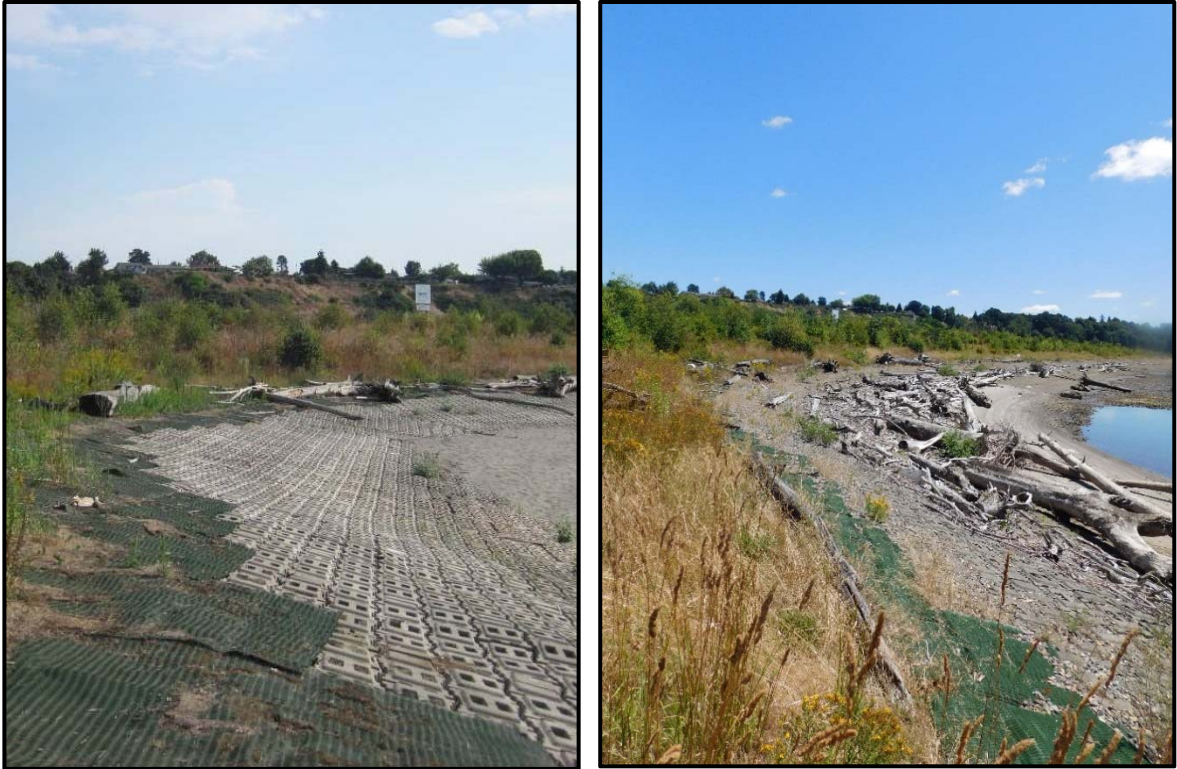
Photograph 7 – Vegetation growth and wood debris within the lower riparian component and along the shoreline. Taken looking southeast from Photograph Location 7 comparing baseline and current conditions. (Left - September 2011, Right – June 2016)

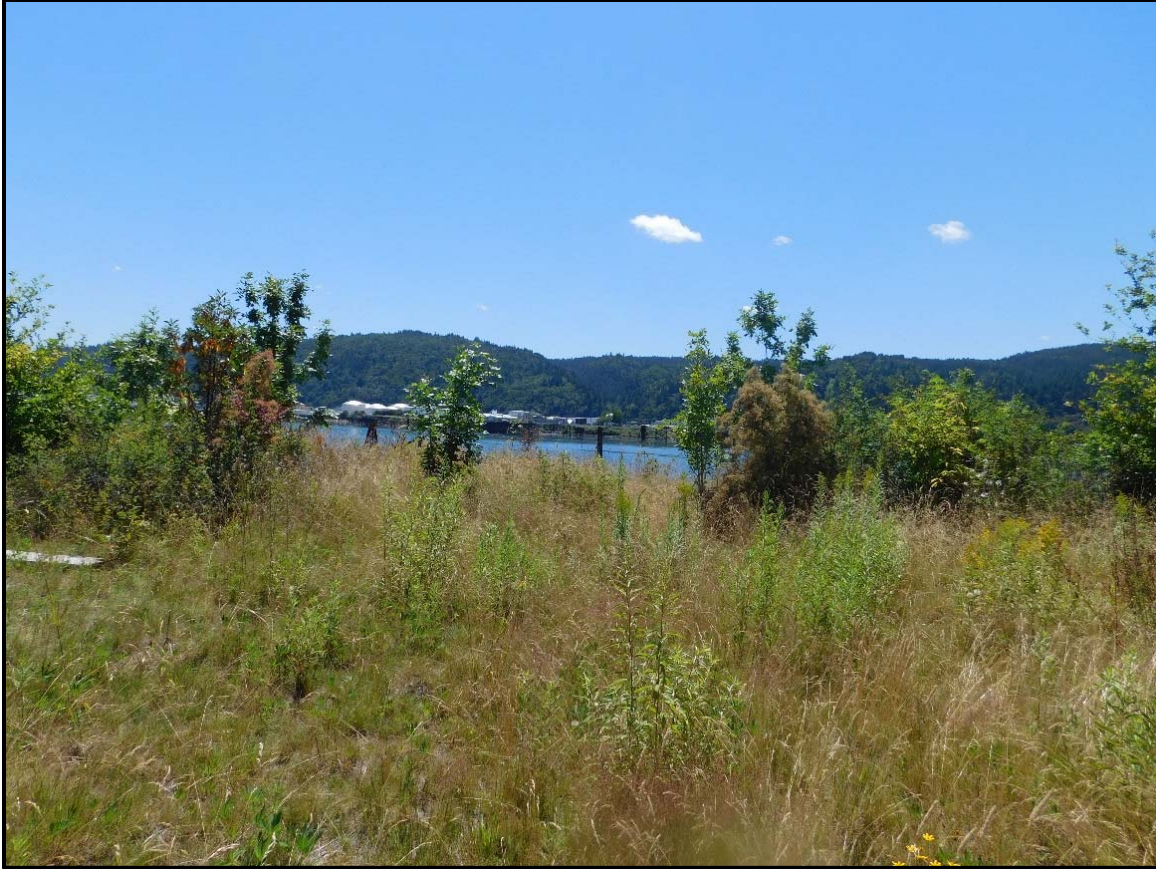
Photograph 8 – Upper riparian component with native trees and shrubs performing well. Taken looking southwest from Photograph Location 8. (June 2016)
